SMELT SPOUT CORROSION IN A RECOVERY BOILER

Dissertação apresentada à Universidade Federal de Viçosa, como parte das exigências do Programa de Pós-Graduação do Mestrado Profissional em Tecnologia de Celulose e Papel, para obtenção do título de *Magister Scientiae*.

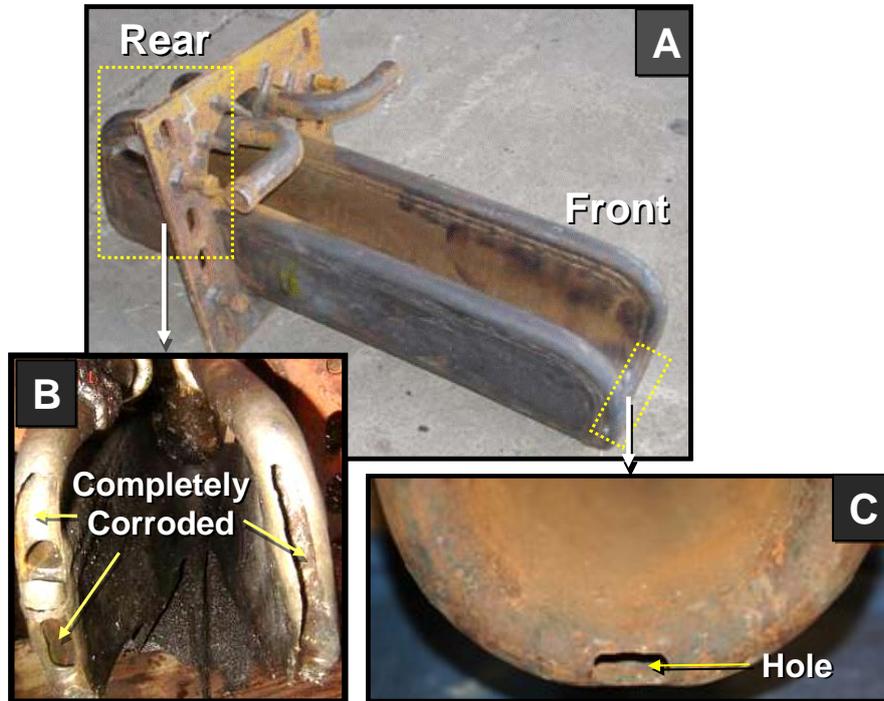
Figure 2. Large perforations at the rear end and a hole at the front lip of the severely corroded Spout #5.

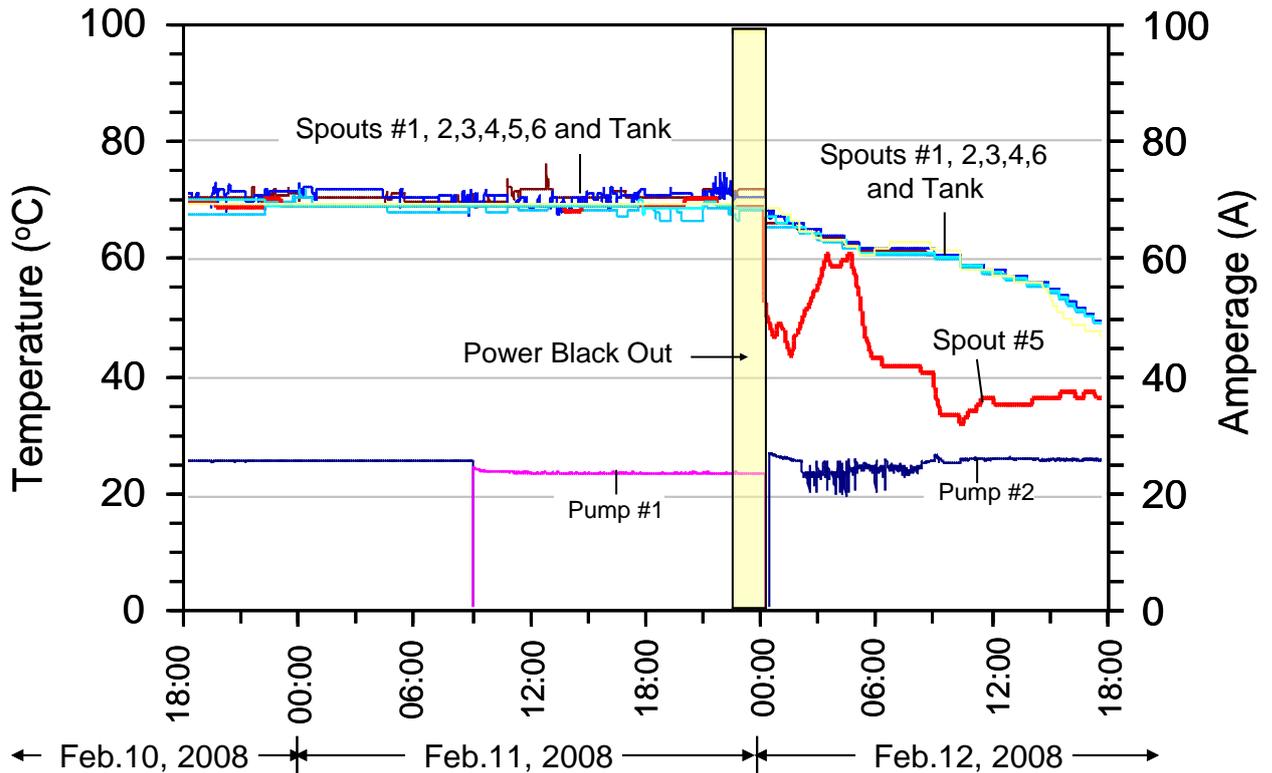
Figure 4 shows the trend data for the cooling water temperatures from individual spouts and the amperages of the recirculation pumps for the period before and after the blackout. Before the blackout, the cooling water temperature from all six spouts appeared to be normal, $70 \pm 3^{\circ}\text{C}$. After the black out, however, the cooling water temperature of spout #5 behaved erratically and was much lower than those of other spouts. This indicates that something had happened to spout #5, although it was not noticed at the time because the boiler was down.

Figure 4. Cooling water trend before and after the blackout period

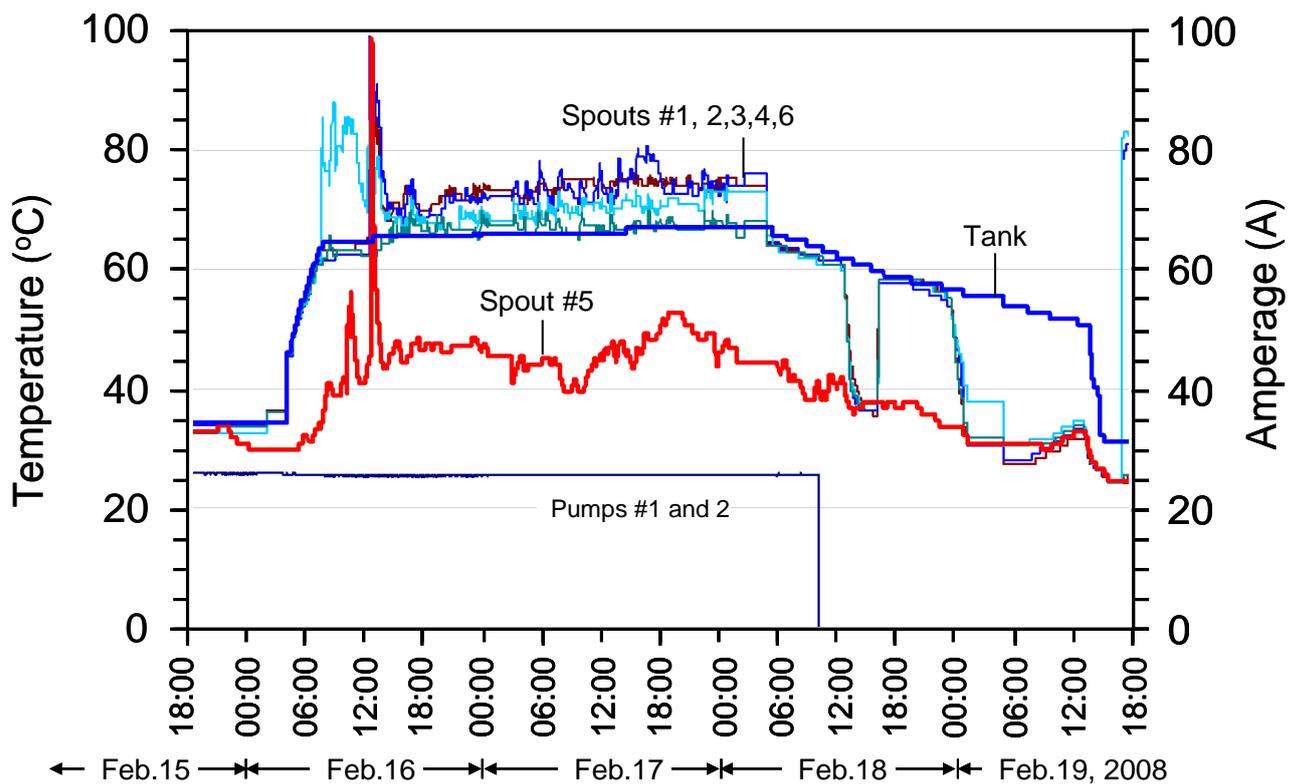
The boiler was firing 1800 t BLds/d when ESP was initiated. The sequence of events shows that the boiler had been burning black liquor with spout #5 operated at an usually low cooling water temperature for nearly 2 days before the ESP.

Figure 5. Cooling water trends on restart of #2 recovery boiler

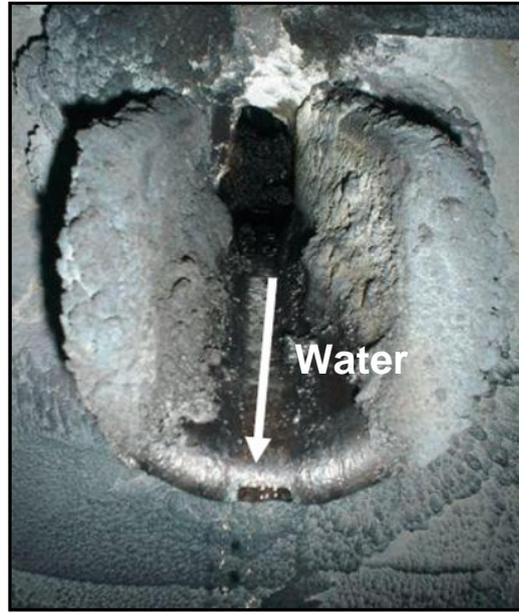
An initial inspection at the smelt spout floor about 12 hours after the ESP showed water running down the trough of spout #5 from within the furnace as well as from a hole at the

Figure 6. Water running out of spout #5 from inside the furnace, 12 hours after ESP.

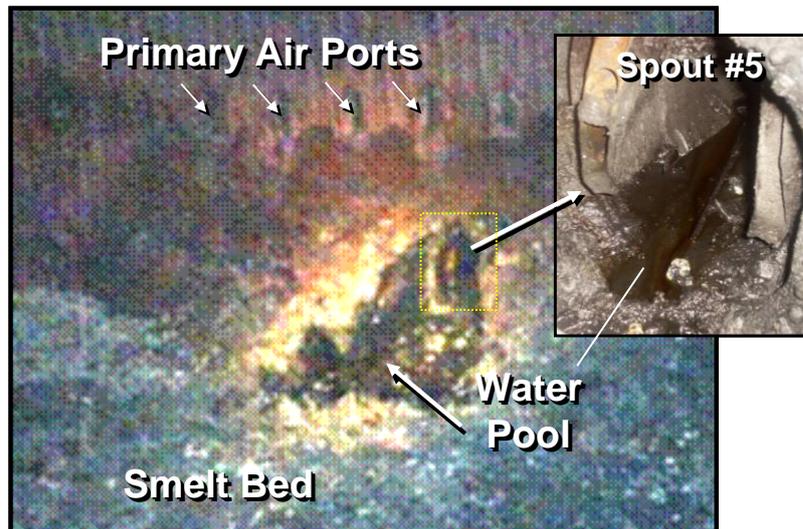
spout lip (Figure 6). From a mandoor one floor above the spout floor, a pool of water could be seen around spout #5 (Figure 7). A close look at the rear end of the spout revealed that the inlet and outlet of the cooling water tubing and the trough were completely corroded through, and some water still remained on the trough (Figures 7, 2B, and 8B).

Figure 7. Water pool accumulated on frozen smelt bed at the spout #5 opening. Box photo shows extensive damage to the cooling water tubing and water on spout trough

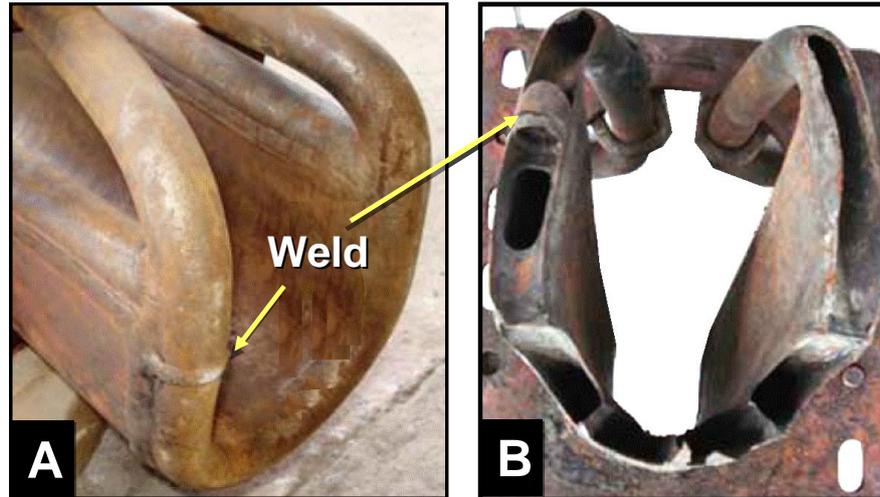
Non destructive dye-penetrant tests, thickness measurements and visual inspection were performed on all spouts and waterwall tubes near spout openings. The results showed that waterwall tubes were intact and that spout #1, 2, 3, 4 and 6 were in excellent condition with no signs of thinning, cracking or internal deposits. On spout #5, however, in addition to large perforations along the cooling water tubing at the rear end of the spout, there appeared to be a defect in the weld that joined the inlet cooling water tube and the outlet tube as can be seen on figures 8A and B.

Figure 8. (A) Weld connecting the cooling water tube to the spout at the rear end of a good spout. (B) Suspected "defect" on the weld joining the inlet and outlet cooling water tubes of spout #5

The suggested “defect” found in the weld of spout #5 (Figure 8) may play a role in its failure. It is possible that the sudden temperature change in the boiler due to power blackout may have caused the weld to fail, resulting in a small crack through which cooling water leaks out to the furnace. This, in turn, reduces the cooling water flow to the spout, causing it to overheat, and hence, to corrode. As the crack becomes larger, more water leaks out and less passes through the spout, aggravating the problem further.

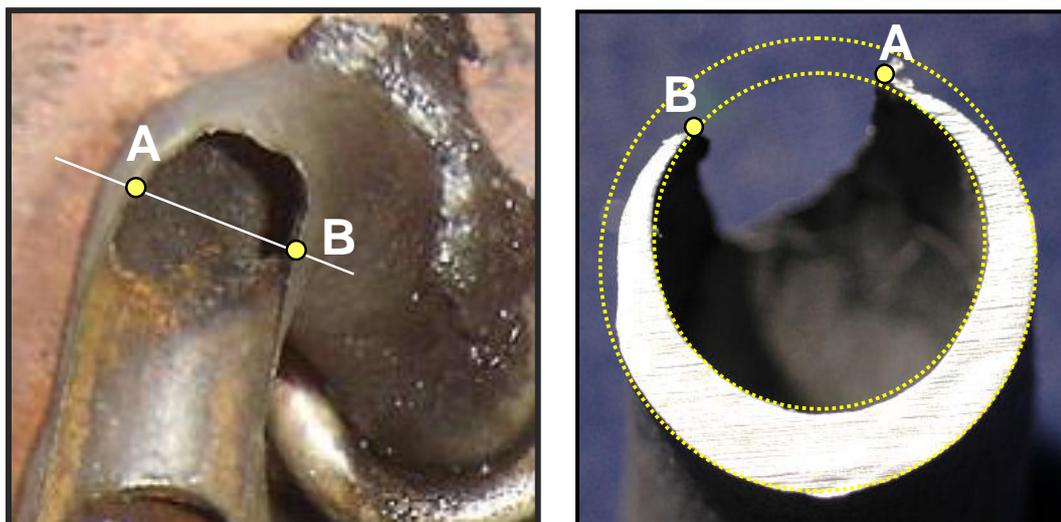
The metallurgical analysis by Nalco revealed that the metal loss of spout #5 was mainly from the external surface (Figure 9). In the areas of severe wastage and along the bottom of the trough, the metal surface was smooth with signs of gouging, resulting presumably from the erosion-corrosion action of molten smelt flowing over the spout surface (Figure 10). The analysis also revealed that the wastage on spout #5 was mainly on the furnace side where heat input is greatest, suggesting a strong temperature dependence of corrosion rates. The microstructure consisted of spheroidized carbides in a ferrite matrix (Figure 11), suggesting that the metal temperature must have exceeded 540°C (1000°F) for a period of time.

Figure 9. Cross section through a perforation on the cooling water tubing of spout #5 showing severe external metal loss. Broken circles are contours of original tube surfaces. The difference in original tube thickness is due to bending.

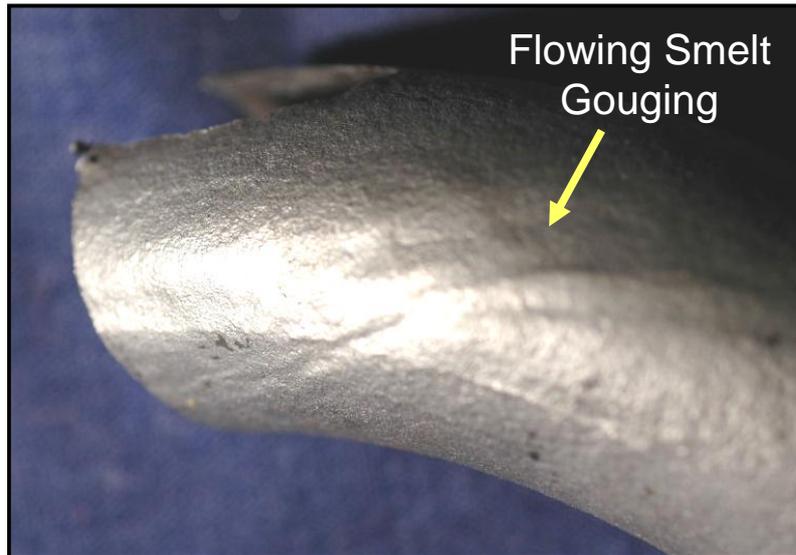
Figure 10. Smooth surface of spout #5 with signs of gouging by molten smelt.

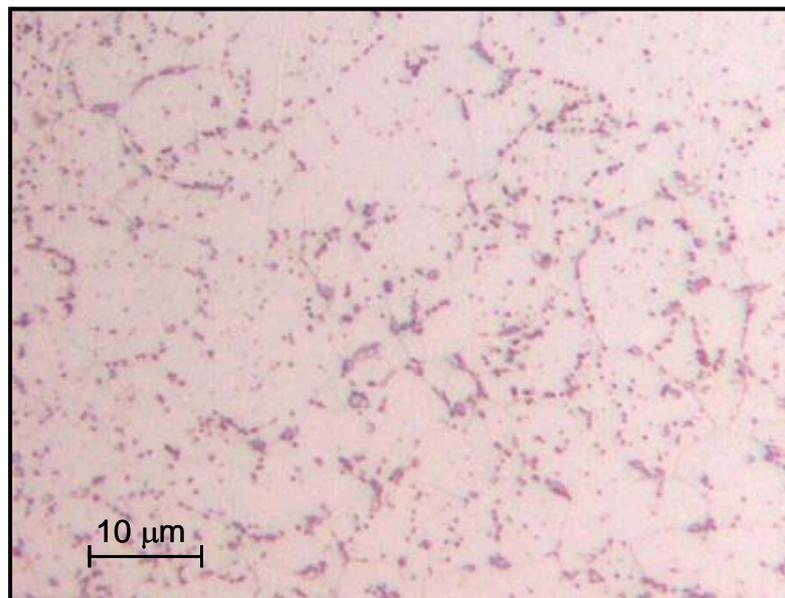
Figure 11. Microstructure of the metal near the corroded area of spout #5

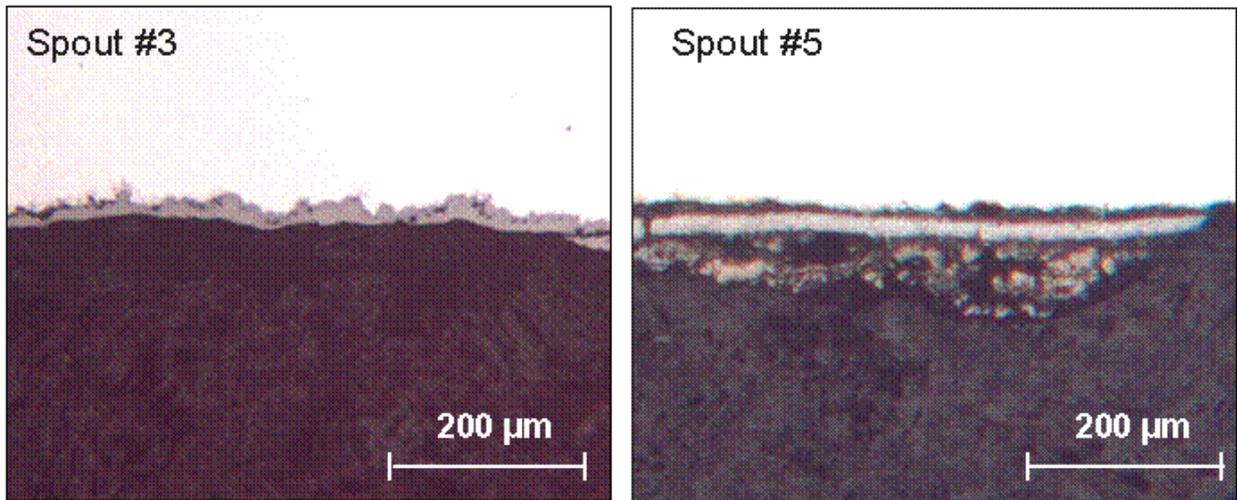
Although some wastage was also observed along the bottom of the trough of spout #3, the extent was insignificant and was expected of a smelt spout that has been in service for 10 months. The internal surface was covered with only a thin and dense layer of oxides (Figure 12), as opposed to thick layers of deposits and oxides observed on the internal surface of

spout #5. This implies that spout #3 did not experience significant overheating, despite the fact that it had its cooling water flow cut off just before the ESP and would have been exposed to smelt flow for some time while the ESP was in effect.

Figure 12. Internal surface of Spout #3 (left) and Spout #5 (right)

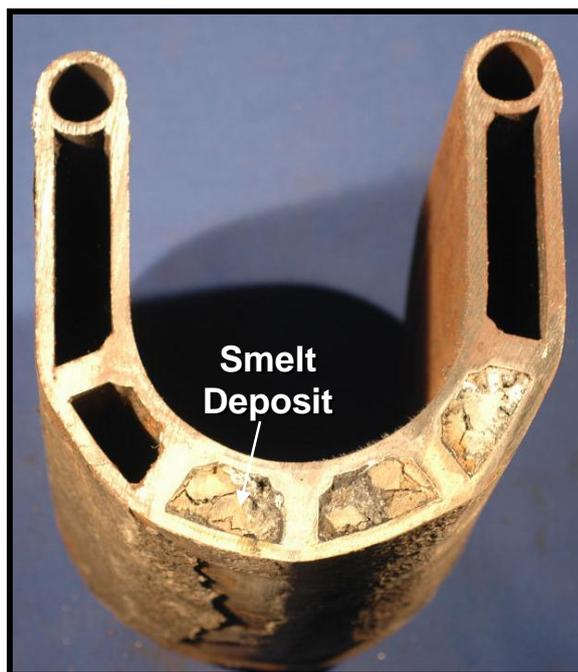
The leaked water begins to accumulate in the furnace near the spout when there is more of it there than it can vaporize. It forms a pool of concentrated smelt solution (saturated green liquor) which pours out the boiler through the spout. This concentrated smelt solution can also be detrimental to the spout (carbon steel) for two main reasons: i) it contains corrosive $\text{Na}_2\text{S}_2\text{O}_3$ as a result of partial oxidation of Na_2S in the solution, and ii) it cannot vaporize easily due to boiling point rise and thus can remain as liquid at a temperature as high as 180°C [3]. Some smelt solution entered the interior of spout #5 where it re-crystallized to form deposits, leading eventually to complete clogging of cooling water passes, as shown in Figure 13.

Figure 13. Crossed section of spout #5, showing smelt deposits locking cooling water passage.

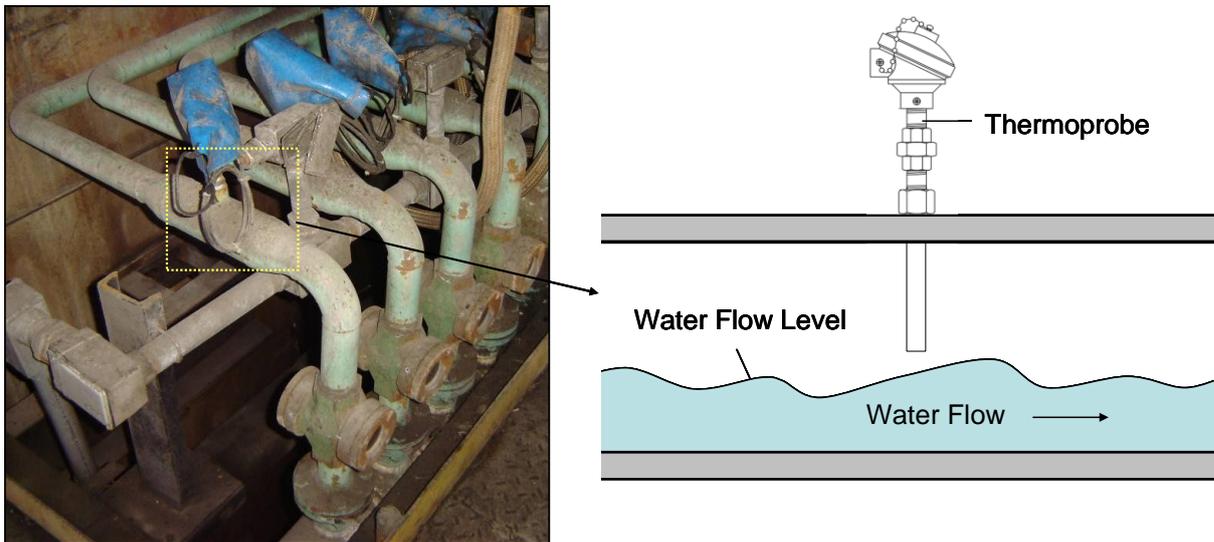
The clogging, in turn, impaired the cooling water flow, forcing it to partially by-pass the spout and flow directly to the outlet tube. This could be one of the reasons for the lower cooling water temperature of spout #5 compared to other spouts. There are two other possible reasons for the low cooling water temperature. One is the lower flow rate and temperature of molten smelt flowing over the spout because of the cooling effect of leaked water. The other is that due to the reduced flow rate of the cooling water from spout #5, the water level in the pipe line was low, and so, the thermoprobe might not be able to “touch” the water to provide proper temperature readings (Figure 14).

Figure 14. Thermoprobe and suspected water level in the cooling water pipe line during the time of reduced flow rate.

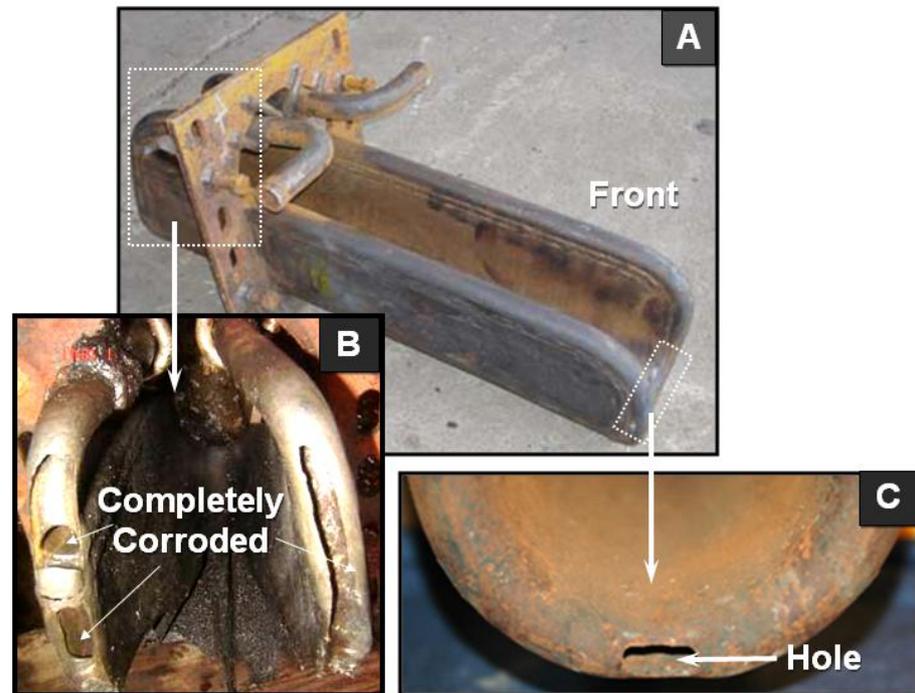
Corrosion in Spout #5

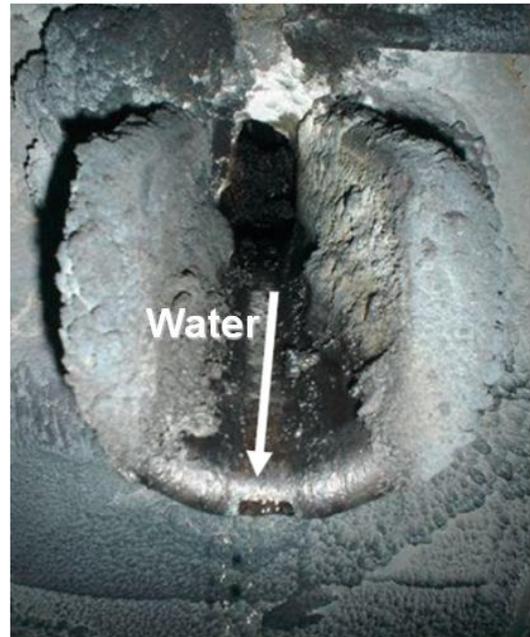
- Water was still running down the trough of spout #5 from within the furnace as well as from a hole at the spout lip about 12 hours after the ESP

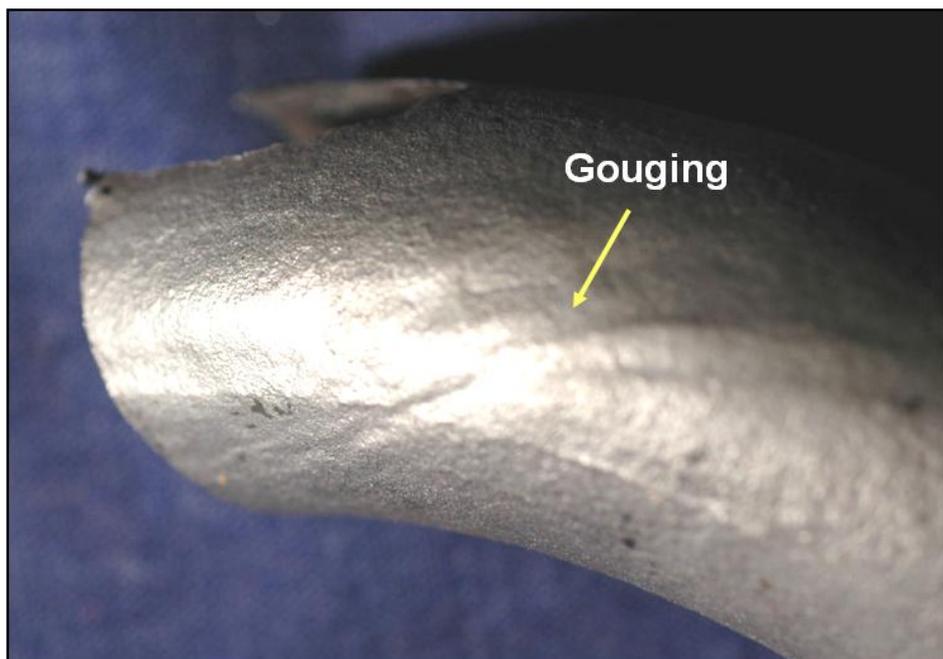
Flowing Smelt Gouging

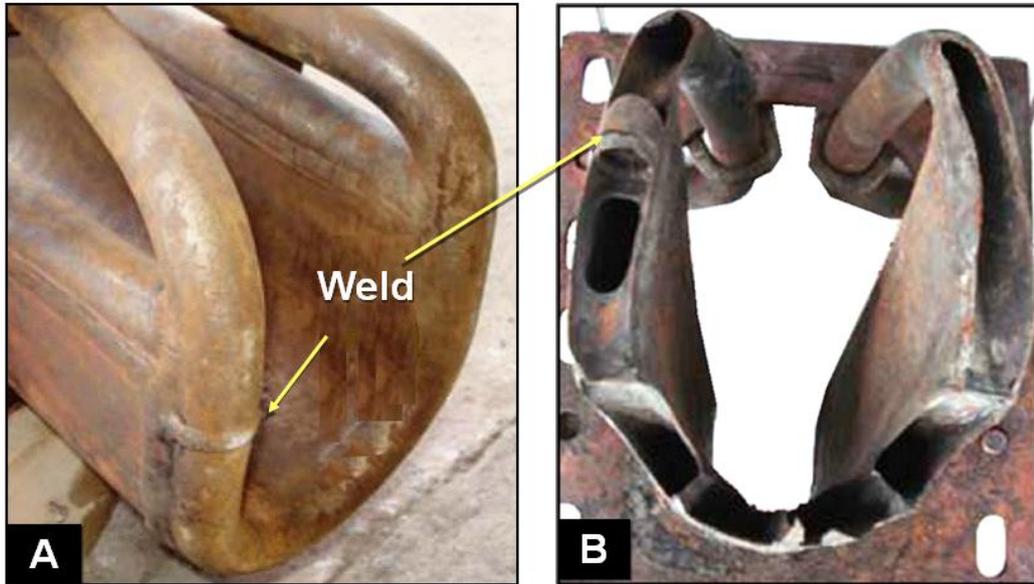
Weld Defect?

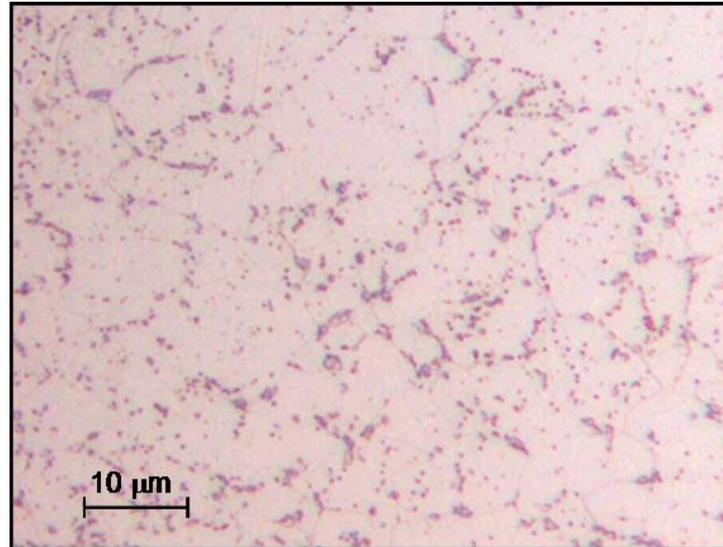
Microstructure of the metal near the corroded area of spout #5

Microstructure consisting of spheroidized carbides in a ferrite matrix → Typical of overheating.

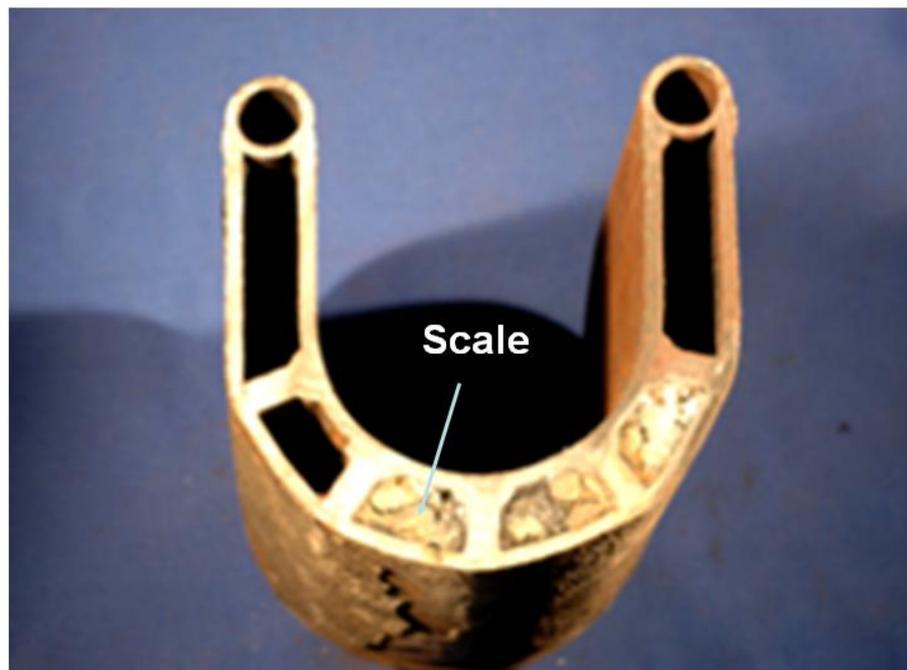
Smelt Deposits in Water Passages
