SMELT SPOUT CORROSION IN A RECOVERY BOILER

Dissertação apresentada à Universidade Federal de Viçosa, como parte das exigências do Programa de Pós-Graduação do Mestrado Profissional em Tecnologia de Celulose e Papel, para obtenção do título de *Magister Scientiae*.

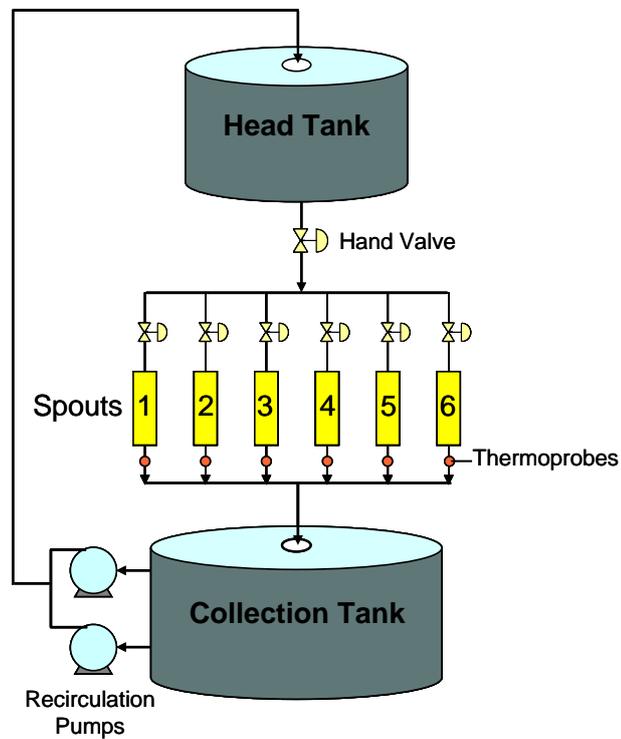
Figure 3. #2 RB smelt spout cooling water system

A thorough inspection was conducted on the spout cooling system, particularly the water lines shown in Figure 3. It was discovered during the inspection that the individual valve identifications were reversed between spouts #3 and #5, although the identification swap had probably been there since the boiler upgrade in 2004. This means that when the operator closed the water valve to spout #5 just before the ESP, he, in fact, shut off the cooling water to spout #3. This explains why water continued to enter the furnace through spout #5 even though the valve was closed. This also means that spout #3 passed through the ESP with no water cooling.

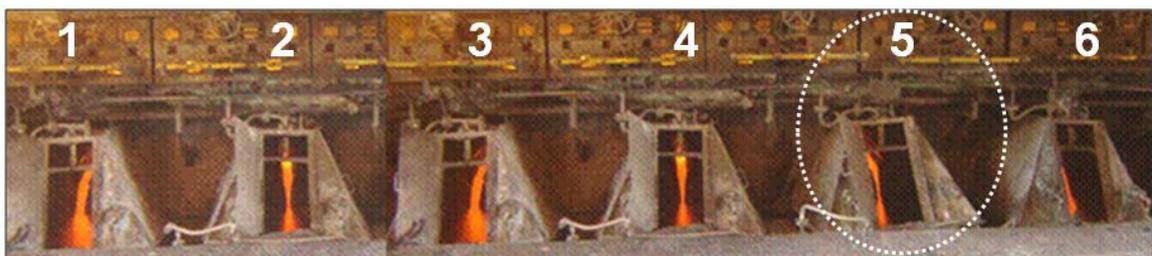
Corroded Spout

Corrosion in Spout #5

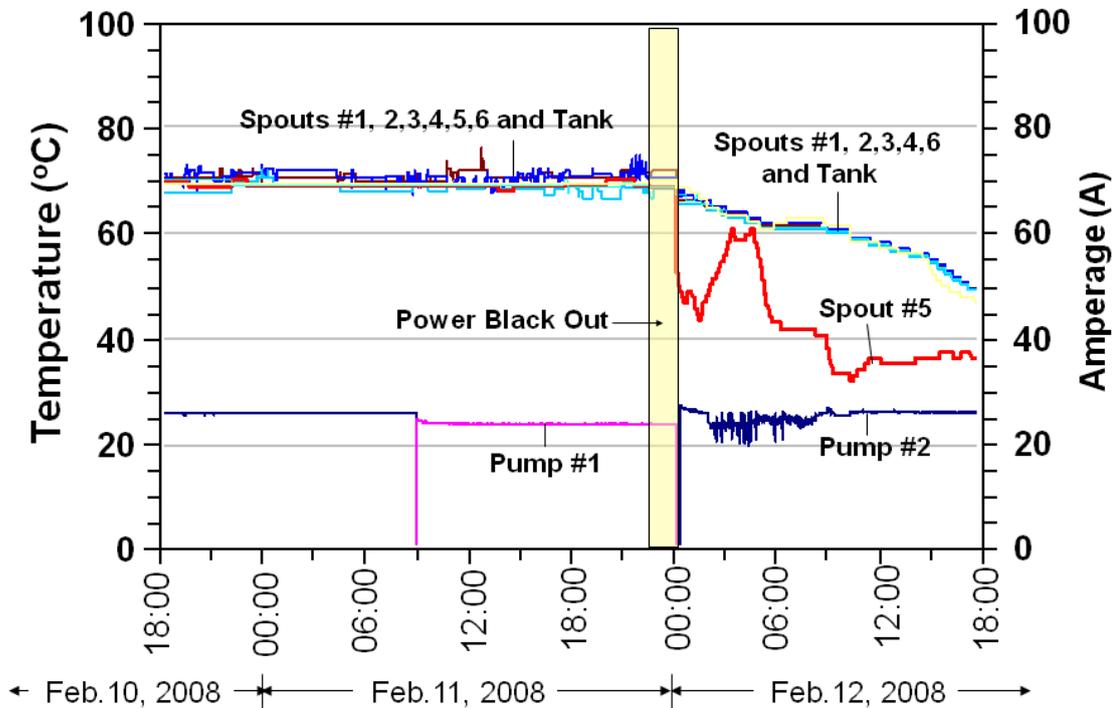
- Short circuit in the TG#1
 - Mill had no power for 71 min.
 - Most emergency systems failed
- #2RB tripped, but smelt continued to flow for some time after the boiler trip
- Both recirculation pumps stopped shutting off the return cooling water flow to the head tank
- The boiler was down for 5 days while TG#1 was repaired

Cooling Water Temperature Profiles Before and After Power Black Out

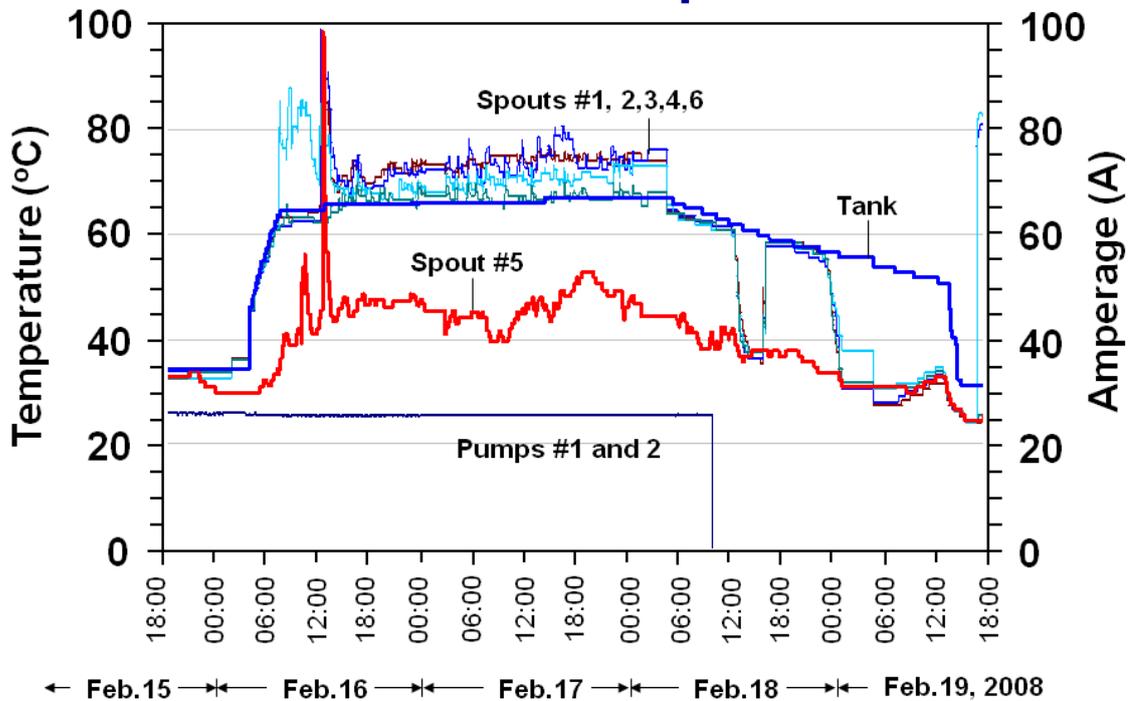
- Began burning liquor at 9:40 AM
- Noted unusually low and erratic cooling water temperature on spout #5
 - Faulty thermocouple was suspected
 - Thermocouple was checked after ESP, but found normal; no replacement was made.

Cooling Water Temperature Profiles After Boiler Start up and ESP

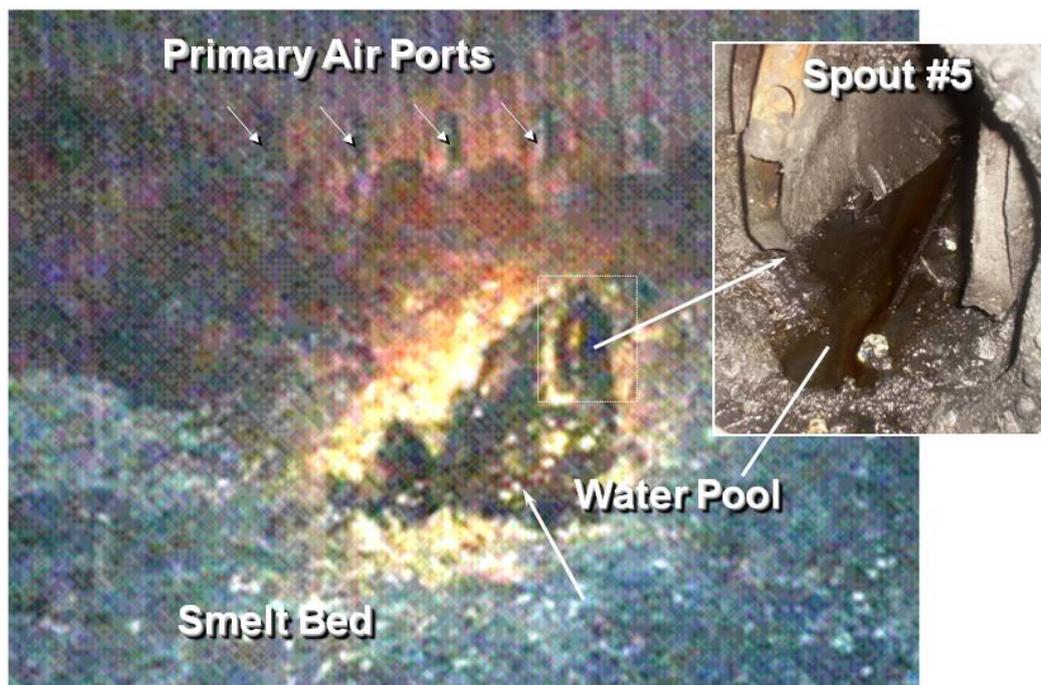
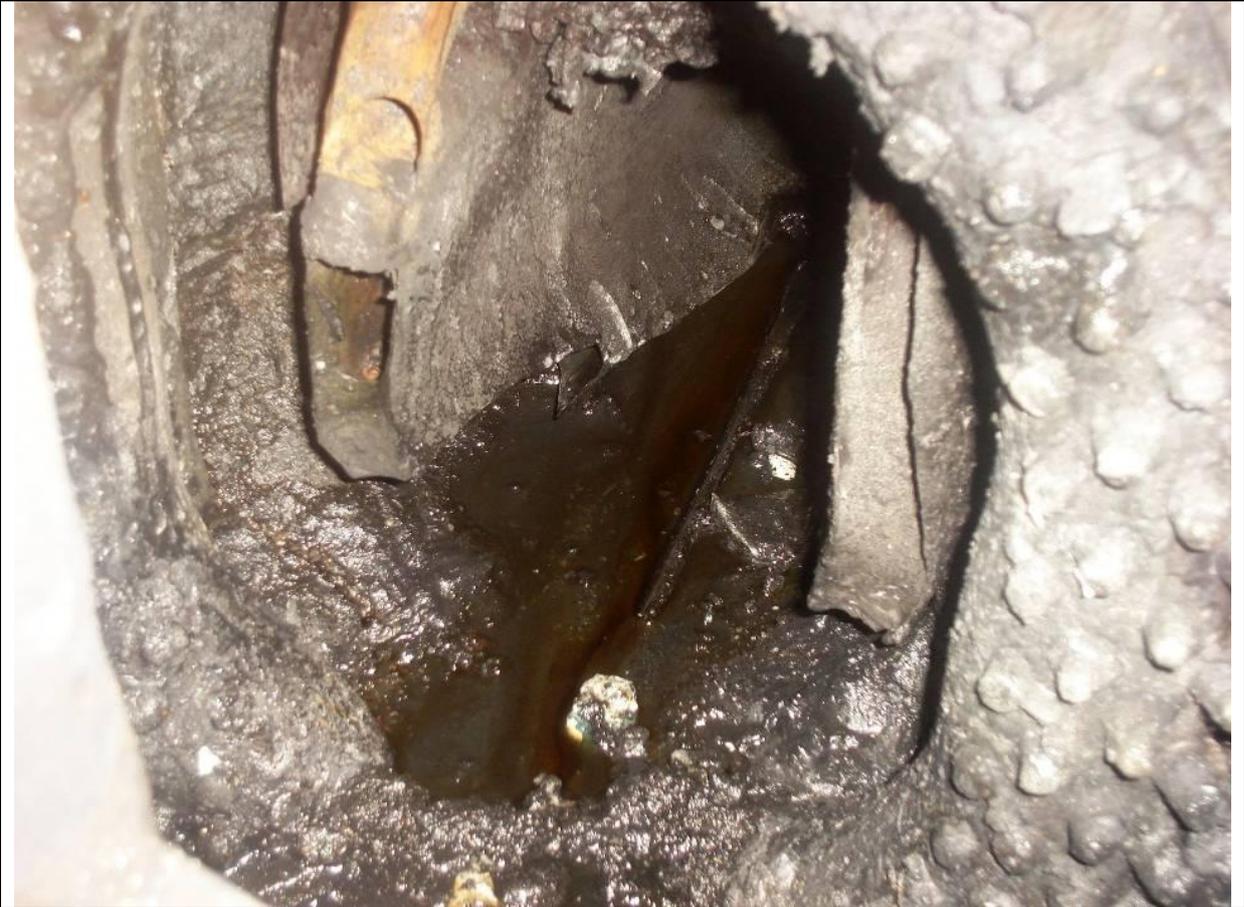
February 19, 2008 - Damage Inspection

spout lip (Figure 6). From a mandoor one floor above the spout floor, a pool of water could be seen around spout #5 (Figure 7). A close look at the rear end of the spout revealed that the inlet and outlet of the cooling water tubing and the trough were completely corroded through, and some water still remained on the trough (Figures 7, 2B, and 8B).

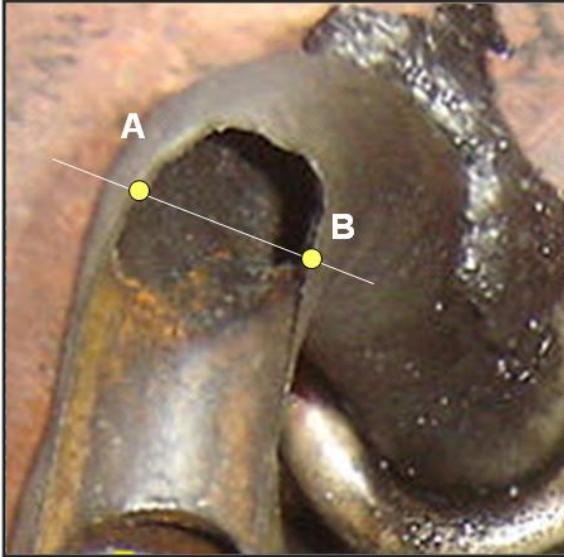
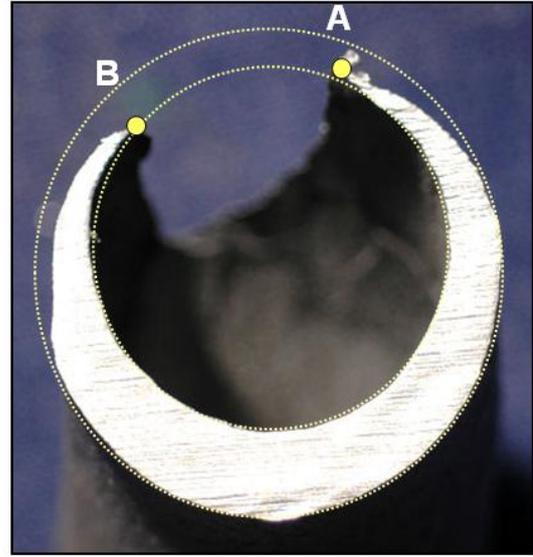
Wall Thickness

- Spouts #1, 2, 3, 4 and 6 were in good shape
 - No sign of thinning or cracking
 - No internal deposits
- Only Spout #5 was severely damaged
 - A “defect” was found in the weld joint between the cooling water tube and the spout
- Metallurgical analysis of damaged area suggests overheating
- Some water passages were clogged with smelt

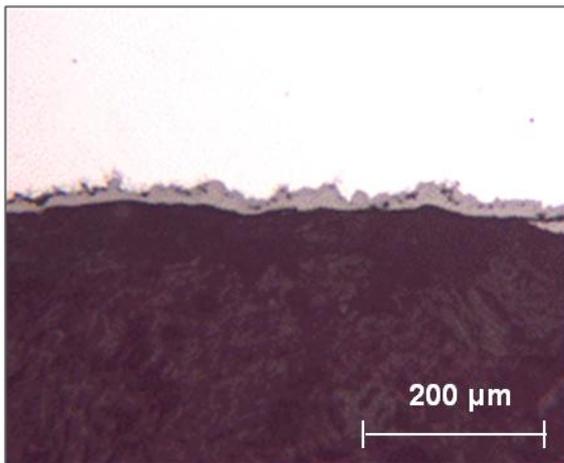
Spout #3

Although some wastage was also observed along the bottom of the trough of spout #3, the extent was insignificant and was expected of a smelt spout that has been in service for 10 months. The internal surface was covered with only a thin and dense layer of oxides (Figure 12), as opposed to thick layers of deposits and oxides observed on the internal surface of

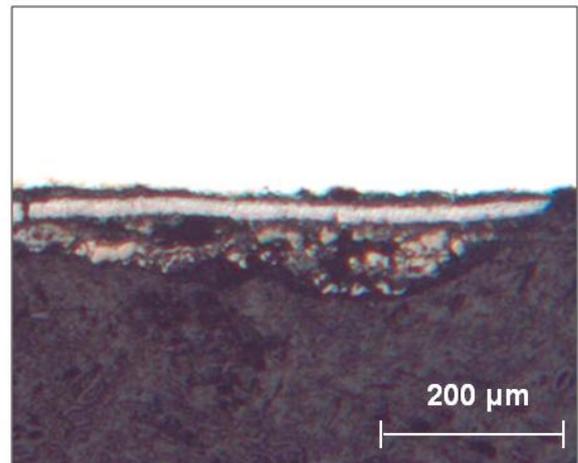
Spout #5

The metallurgical analysis by Nalco revealed that the metal loss of spout #5 was mainly from the external surface (Figure 9). In the areas of severe wastage and along the bottom of the trough, the metal surface was smooth with signs of gouging, resulting presumably from the erosion-corrosion action of molten smelt flowing over the spout surface (Figure 10). The analysis also revealed that the wastage on spout #5 was mainly on the furnace side where heat input is greatest, suggesting a strong temperature dependence of corrosion rates. The microstructure consisted of spheroidized carbides in a ferrite matrix (Figure 11), suggesting that the metal temperature must have exceeded 540°C (1000°F) for a period of time.

They have ran for the same time at the same condition.

Microstructure of the metal near the corroded area of spout #5
