# METHODOLOGY FOR INSPECTION OF WOOD PATHOLOGIES USING ULTRASONIC PULSES

Edgar Vladimiro Mantilla Carrasco<sup>1</sup>, Amanda Rocha Teixeira<sup>2</sup>

Key words: Wooden structures, ultrasound, nondestructive testing, phytosanitary evaluation.

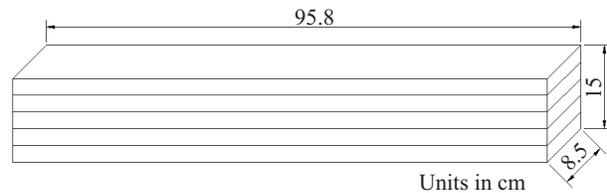
Figure 3 – Dimensions of the glued laminated timber beam.

Materials used in the experiment included a glued laminated timber beam from species *Eucalyptus grandis* (Figure 3), a James Mark II ultrasound device with a pair of ultrasonic pulse transducers acting as the emitter and the receiver, at a 500 kHz frequency (Figure 4).

The selection of a glued laminated timber beam was based on the fact that the piece not only had largely intact areas that allowed measurement of a reference time but also areas with presence of cracks, holes and galleries (caused by insects) of various shapes and sizes. The beam was intentionally manufactured with these internal defects.

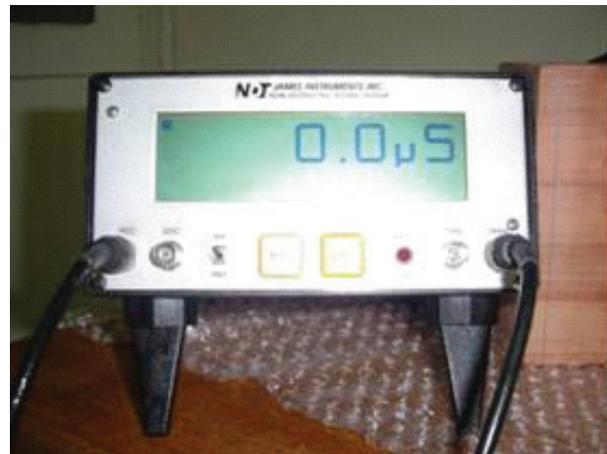
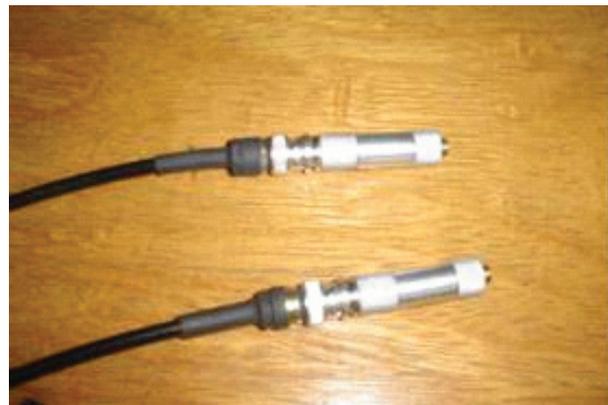
Figure 4 – Ultrasound device (a) and transducers (b).

The recommended transducer frequency in this experiment is 500 kHz as it is sensitive to small openings (galleries made by termites or borers) and cracks on the interior of the wood piece. Detection of holes and cracks was done in the direction of the pulse path. This detection is directly related to the wavelength of the pulse in the laminate where propagation time is being measured. The longer pulse propagation time is, the lower the velocity and, consequently, the shorter the wavelength will be. Detection is only possible if dimension 'a' of the hole or crack follows a  $a \geq \lambda$  ratio, where  $\lambda$  is wavelength.

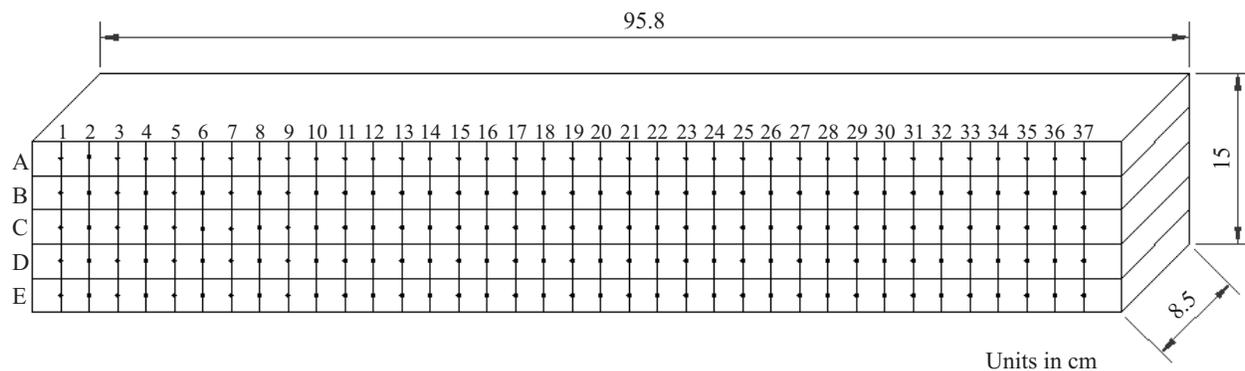
**Figure 5** – Schematic representation of the first grid pattern.

After measuring the reference propagation time, an inspection grid was designed on the beam (Figure 5). A square grid was considered whose edge corresponded to approximately  $10\lambda_m$ , or ten mean wavelengths, adopting

Measurements were taken every 2.5 cm ( $\approx 10\lambda_m$ ) starting on one side of the beam, in all five laminates, as illustrated in Figure 5. Then, propagation times of ultrasonic pulses were measured in all points of the grid pattern.

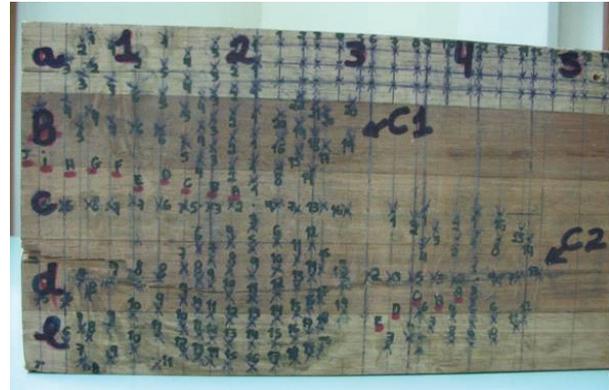
Figure 6 – Actual representation of the second grid.

The second grid pattern was based on the results of the first. Propagation times of pulses obtained with the first grid were compared with reference times of each laminate. Whenever pulse time readings from the first grid pattern exceeded reference time values, the area was considered one with high potential of degradation. The second grid pattern covered only such areas, as seen in Figures 6 and 7. Figures 8, 9 and 10 illustrate such areas in greater detail.

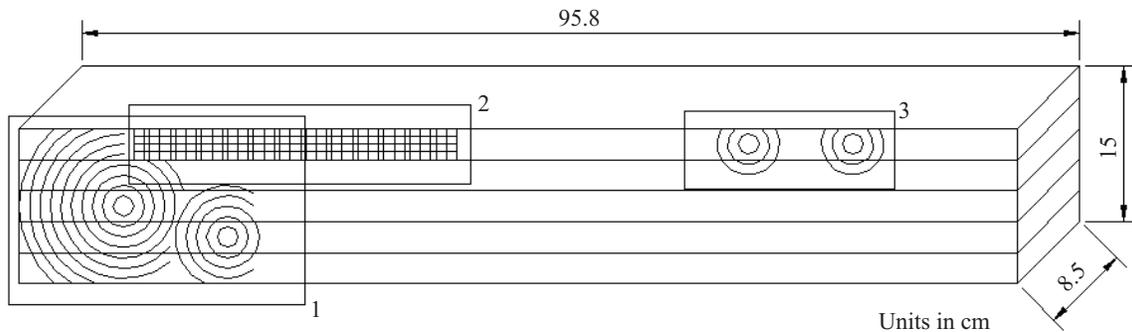
Figure 7 – Schematic representation of the second grid.

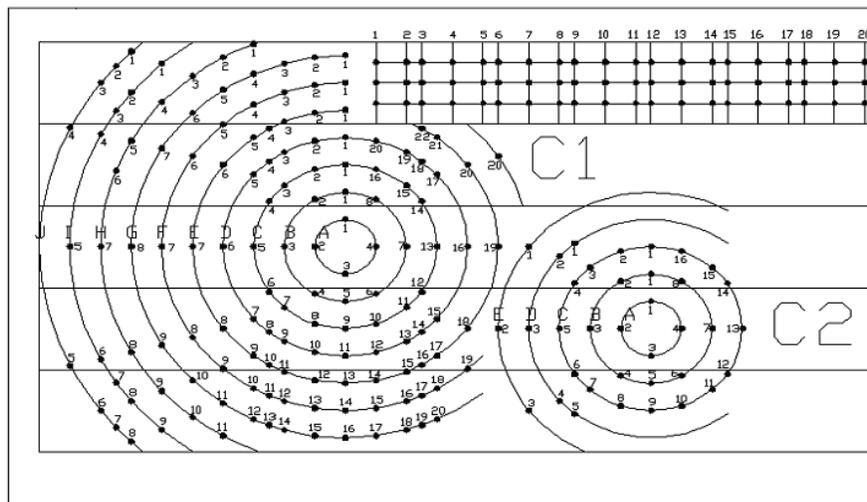
Figure 8 – Area 1 in detail.

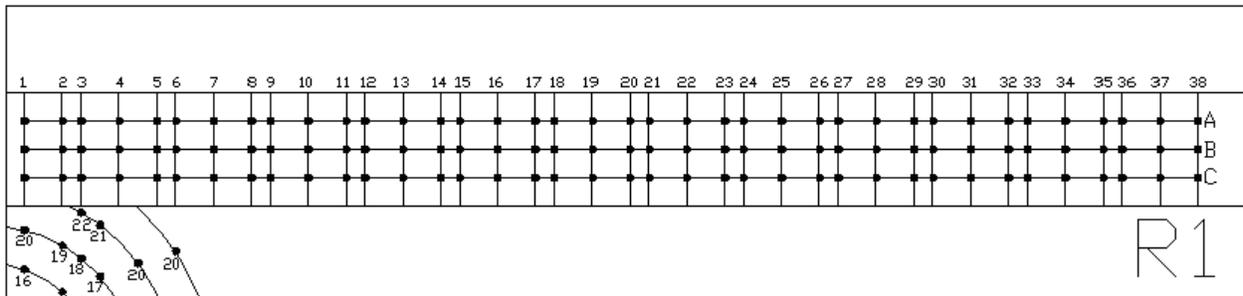
Figure 9 – Area 2 in detail.

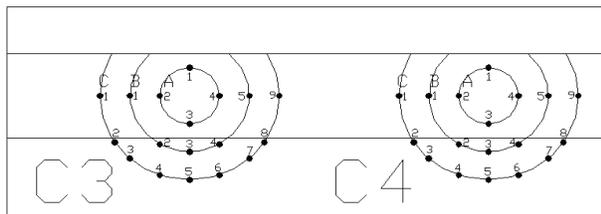
Figure 10 – Area 3 in detail.

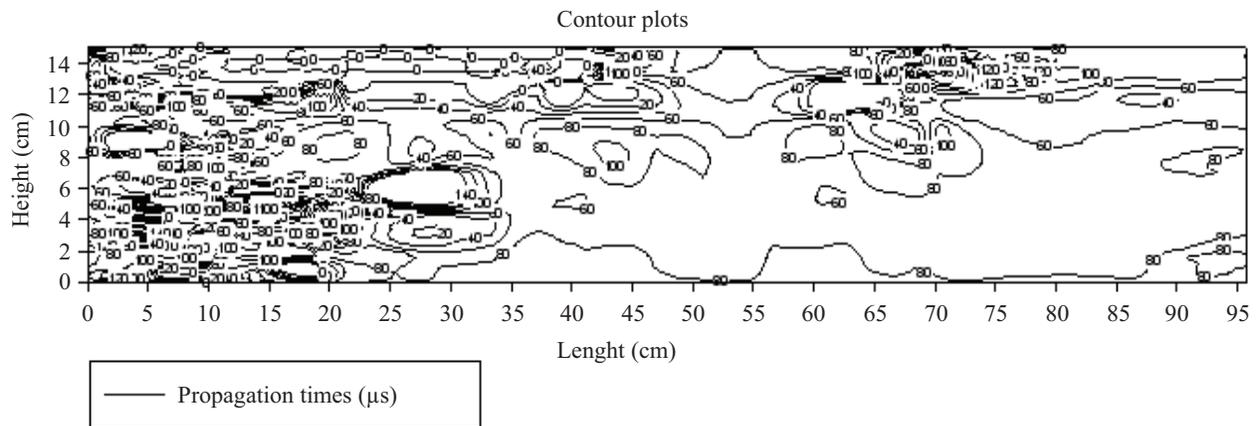
Figure 11 – Contour plots indicating areas with same propagation times.

With the propagation time readings obtained from the second grid, curves were generated, using SigmaPlot® version 10, to represent areas with same propagation times, as seen in Figure 11. This software allowed converting these curves into isochromatic patterns for better viewing of the areas considered degraded (Figure 12).

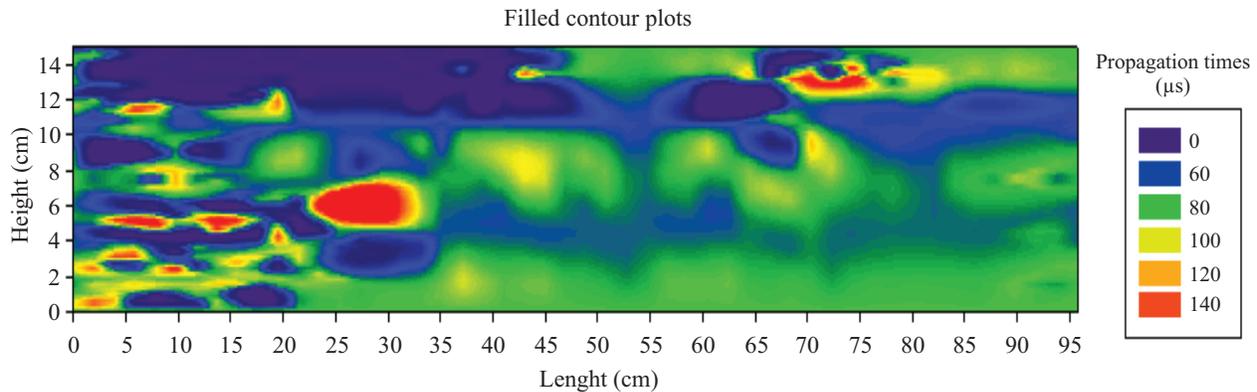
**Figure 12** – Deteriorated areas in the glued laminated beam.

The legend in Figure 12 indicates propagation times, in  $\mu\text{s}$ , required for a pulse to travel from one side of the beam to the other.

A 0 m s value in propagation time can be related to pulse reflection, possibly indicating an obstacle along the path preventing the pulse from passing. And given that the ‘acoustic impedance’ between the interfaces of wood and holes/fissures is substantial ( $a \gg \lambda$ ), the ultrasonic energy is reflected on this interface (hole/wood) and thus fails to reach the receiver transducer positioned on the opposite side of the emitter transducer. These holes or fissures can be highly indicative of defects, including attack by wood-destroying insects. Where  $v$  values ranged from  $60 \mu\text{s}$  to  $80 \mu\text{s}$ , the wood piece was considered sound, that is, free from insect attack, holes or fissures, a fact confirmed by visual inspection.

Values above  $100 \mu\text{s}$ , according to reference propagation times, suggest occurrence of attenuation

caused by fungi or by pulse diffraction due to presence of fissures and cracks, often resulting from the very nature of the wood in question. Whenever a pulse deviates from empty space, the propagation time increases.
